## APPENDIX – 2009 Field Inspection Summaries

Utility: **ComEd** Investigators: **John Stutsman (Staff)**  
Feeder Ckt: **S431** City: **Odell** Voltage: **4/12kV** Date: **Monday, September 21, 2009**

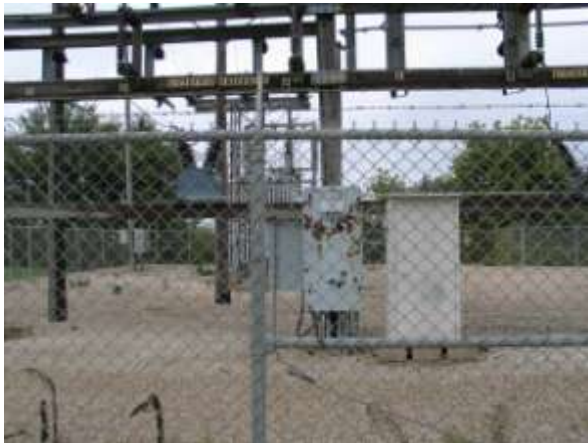
Equipment condition in substation

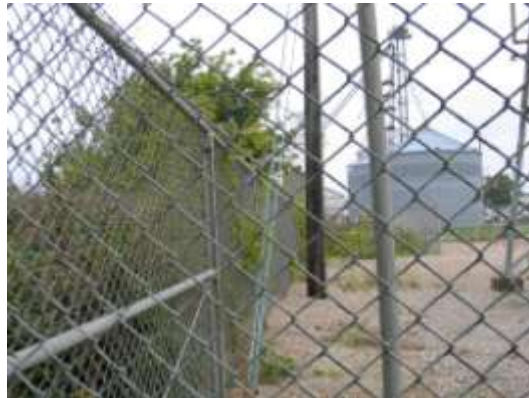
Vines & weeds at substation

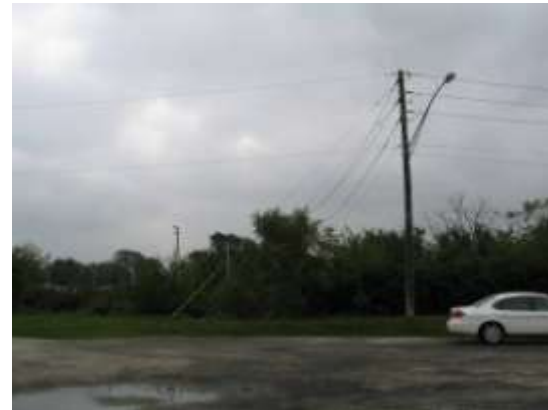
NESC 279 compliance concern

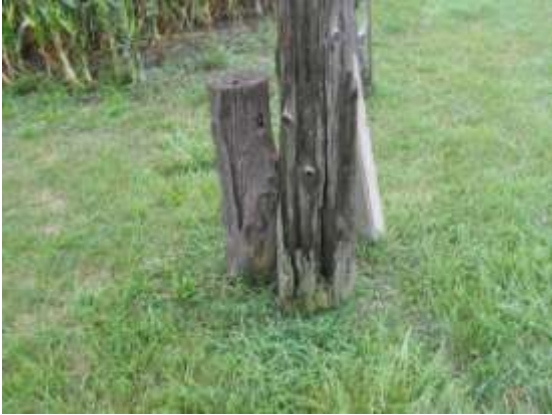
Shell rot

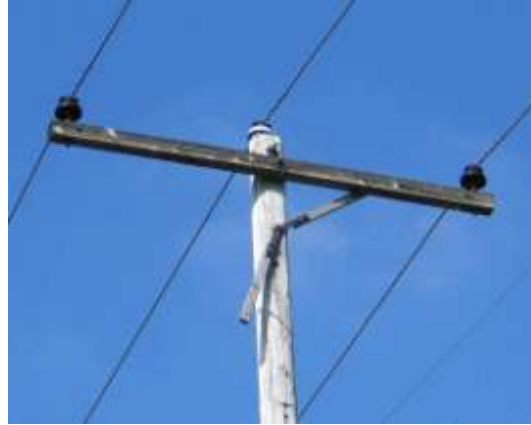
Disconnected cross arm brace

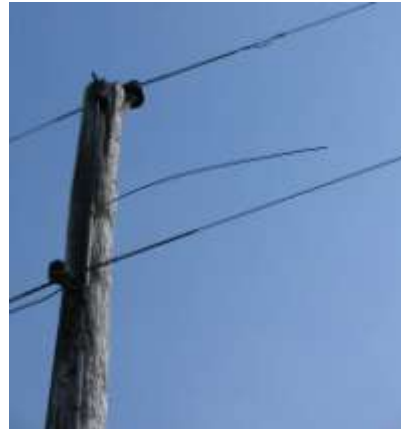
Loose insulator support

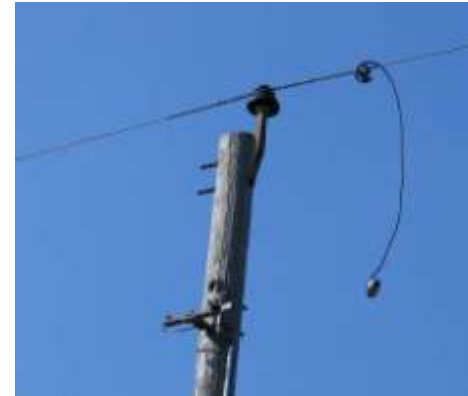
Blown Lightning Arrester

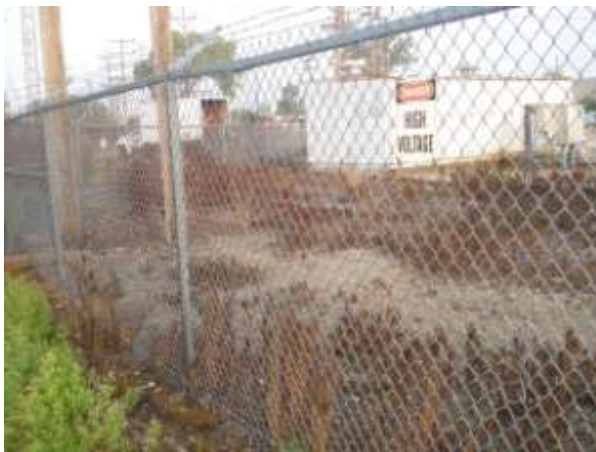
Dead weeds in Substation yard

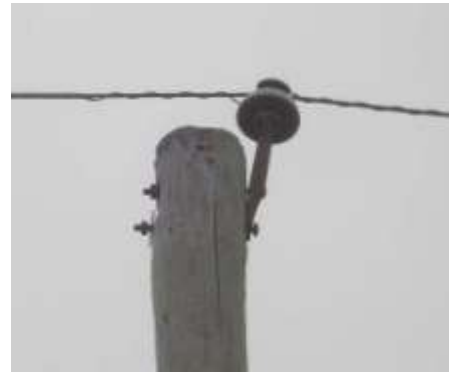
Loose hardware on Primary

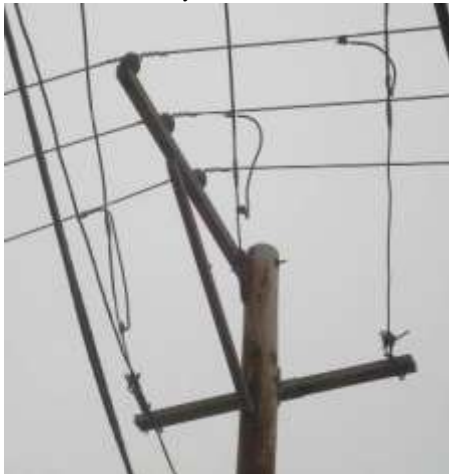
No insulator on Primary – far right of bottom cross arm & side view of same location where insulator

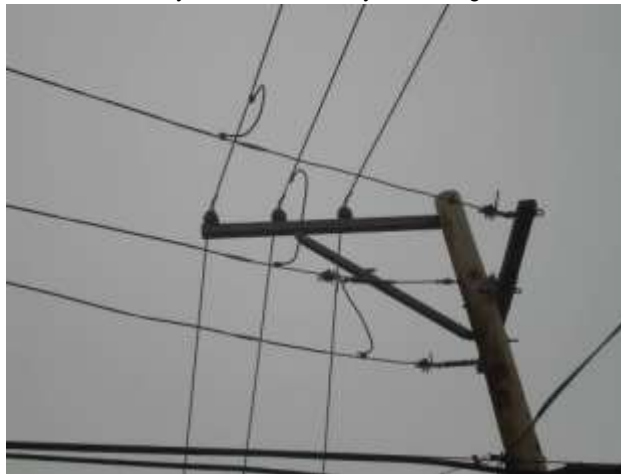
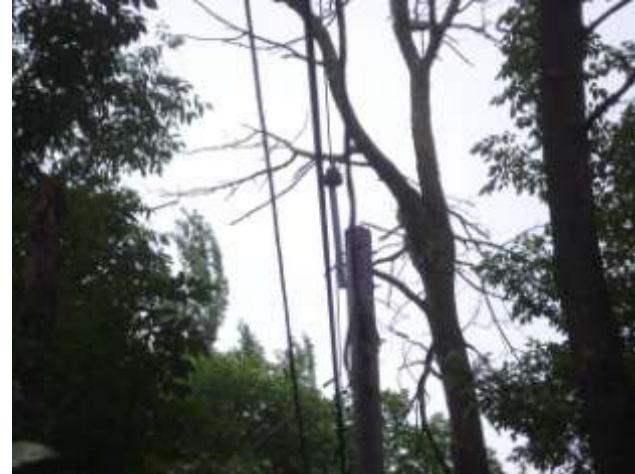
Loose hardware & dead branches over Primary

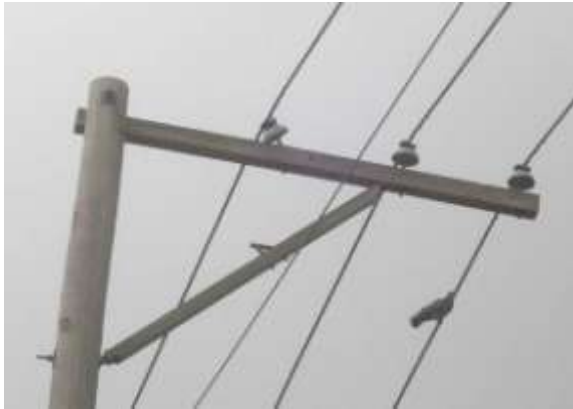
Bent pin, Bushing skirt appears to touch cross arm

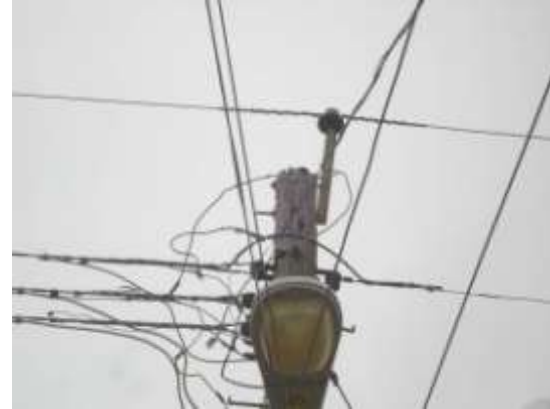
Loose hardware

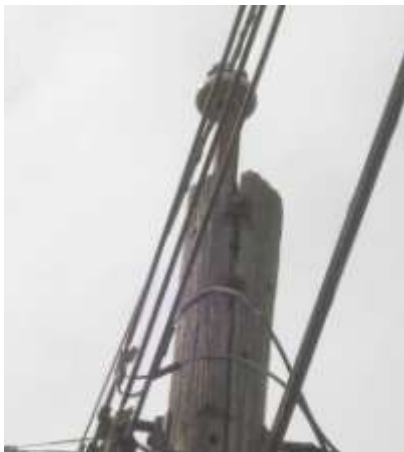
Split Pole Top at bolts supporting Insulator

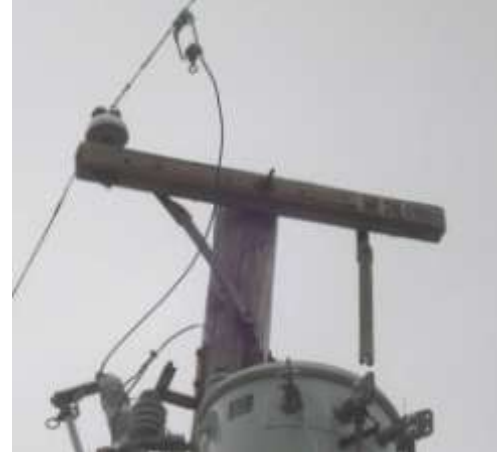
Broken cross arm support

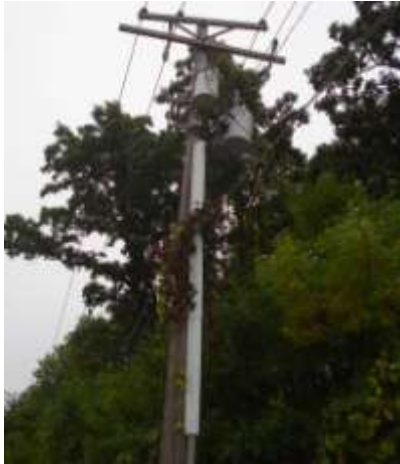
Vines up pole & onto Transformer

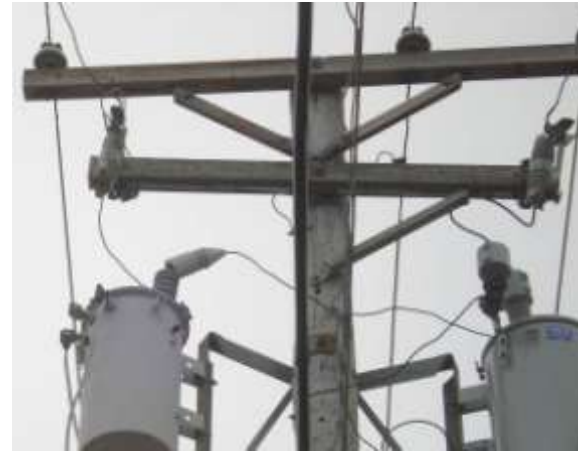
Loose animal guard on transformer bushing

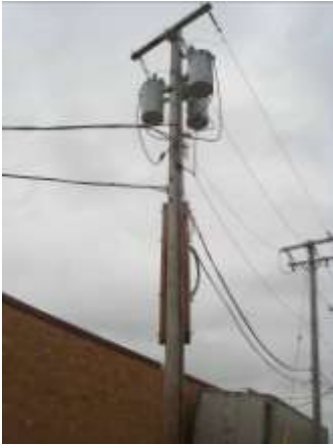
Leaning split pole with cross-arm braces on sides

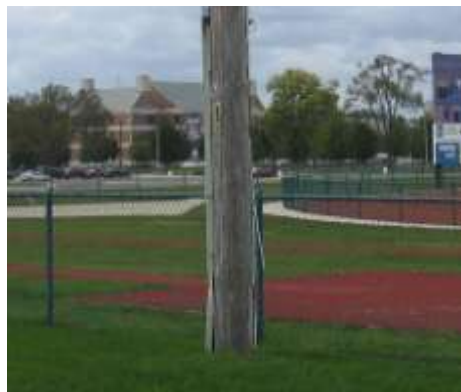
Damaged ground guard & riser guard

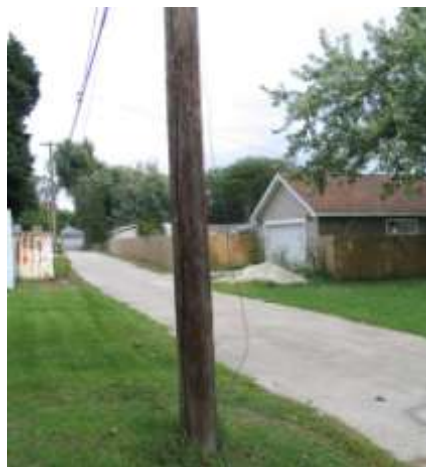
ground wire pulled away

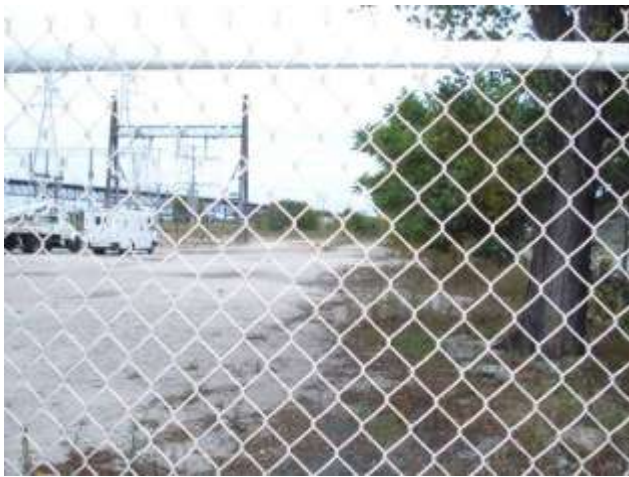
Trees & weeds in substation yard

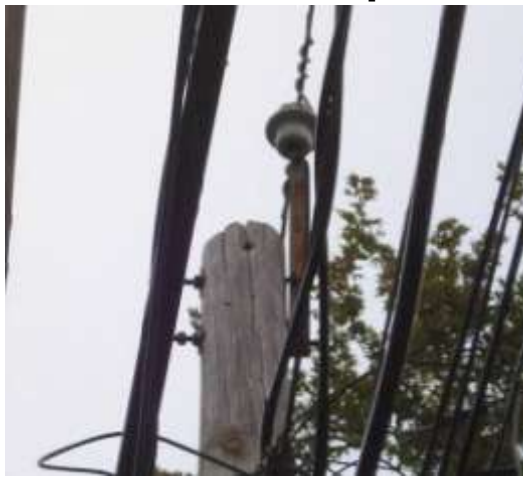
Loose hardware

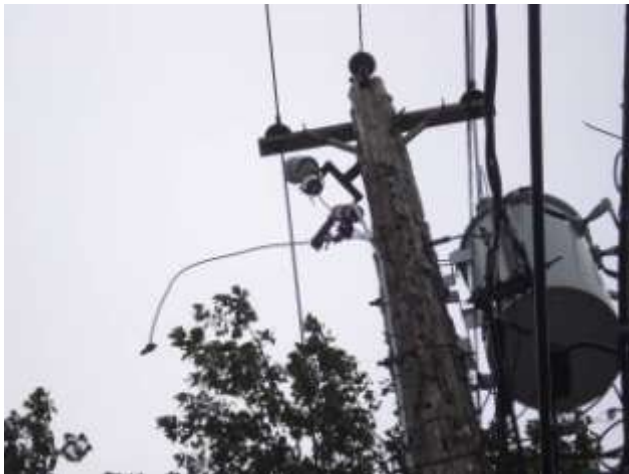
Blown Lightning arrester

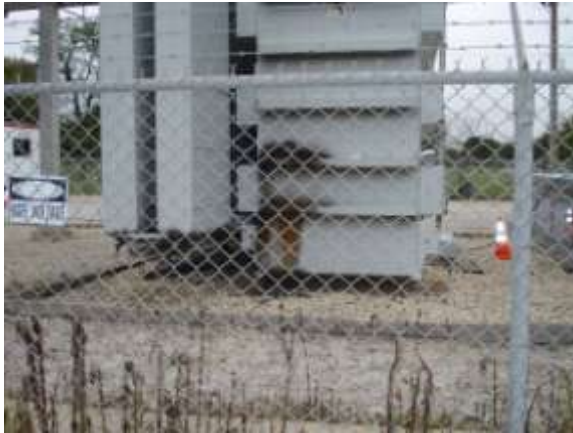
Equipment condition/old oil leak(s)

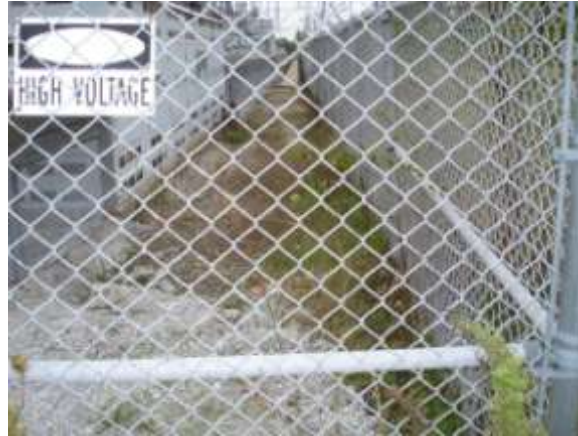
Vines and Weeds in substation

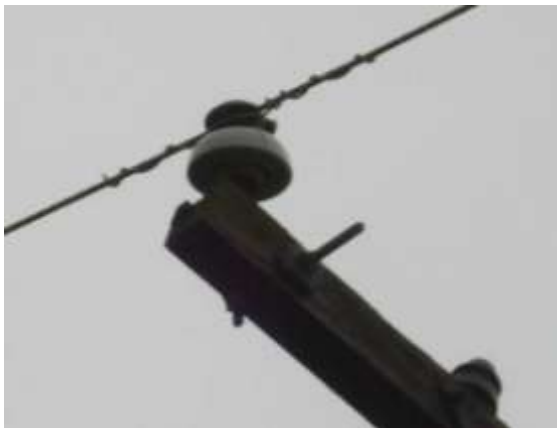
Pin loose in Cross-arm

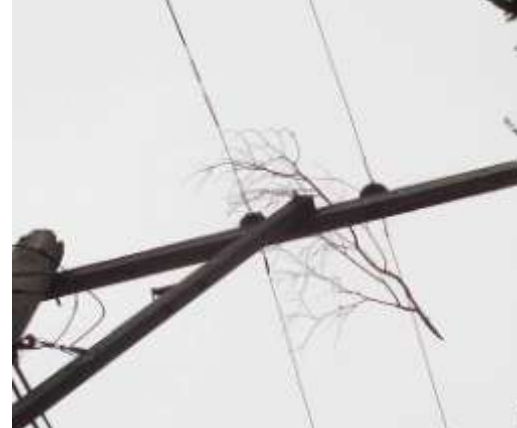
Branch on Cross-arm & Primary

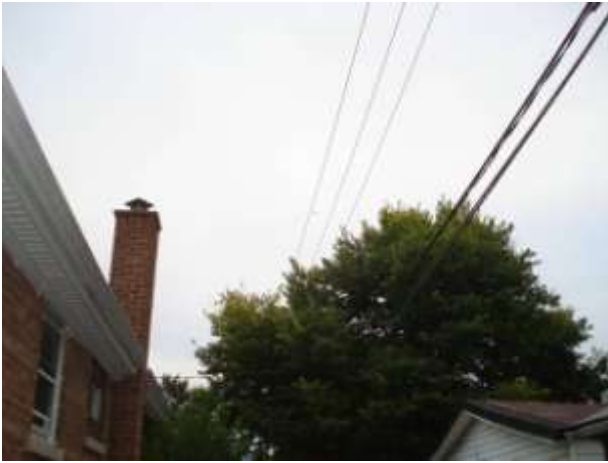
Tree into Primary -- Chicago

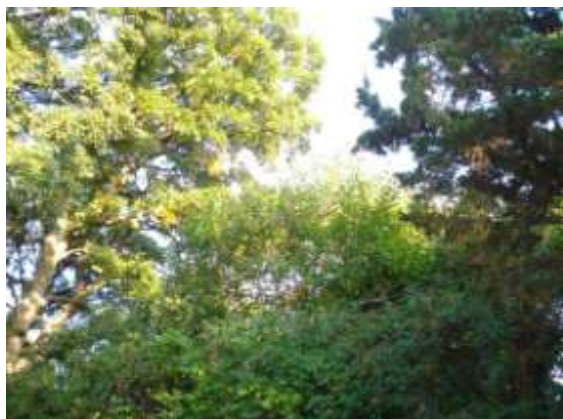
Trees into Primary

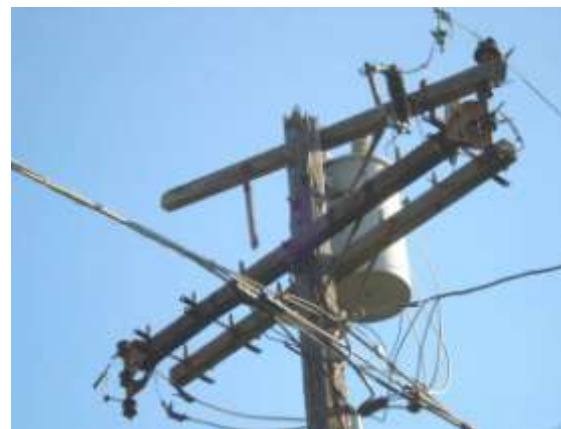
Broken cross arm brace & bad pole top

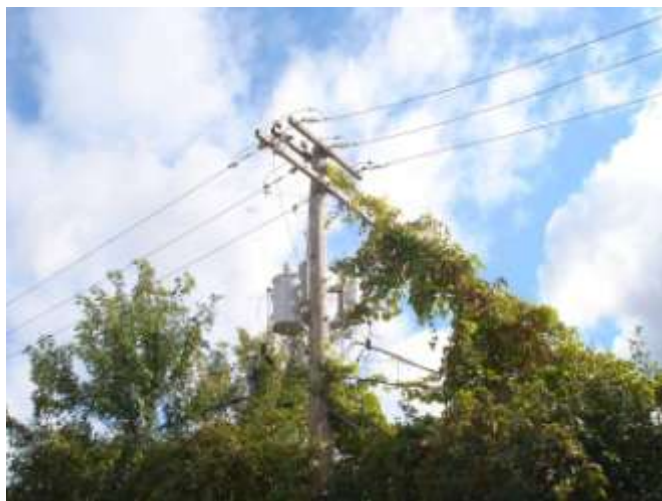
Vines growing to Primary & transformer bank

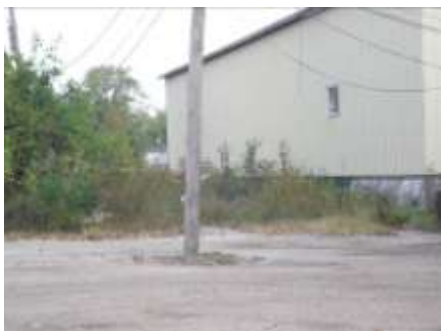
Broken Guy wire wrapped around pole

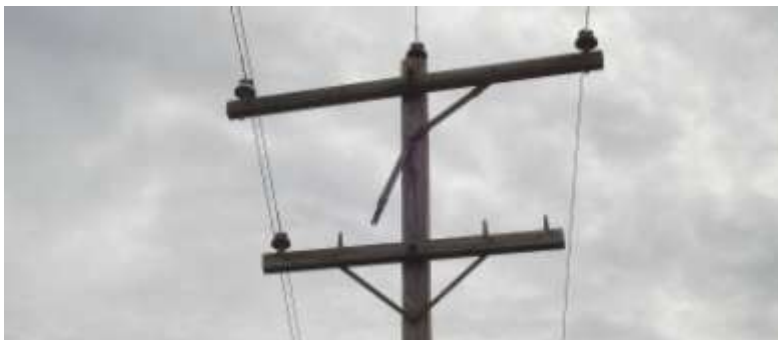
Broken cross arm brace

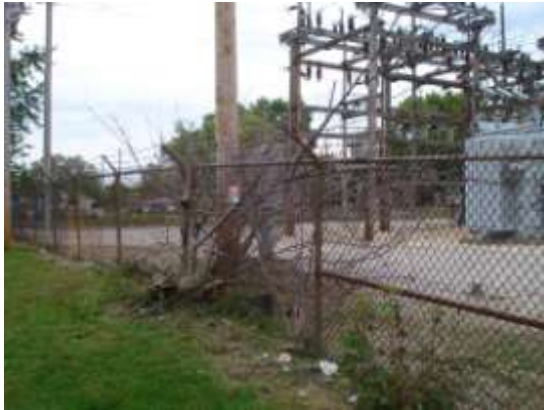
Past vegetation issues at fence of substation

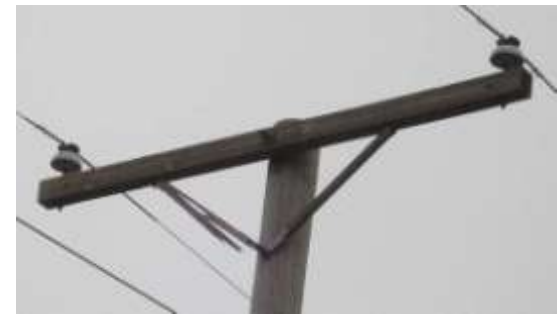
Broken cross-arm brace

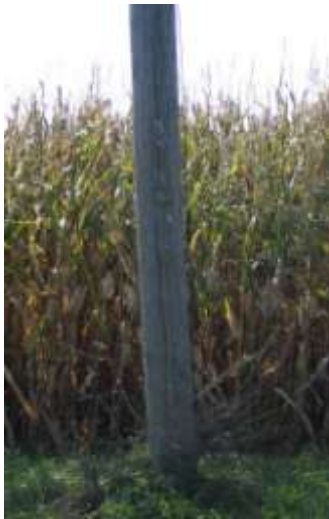
Ground wire hanging loose

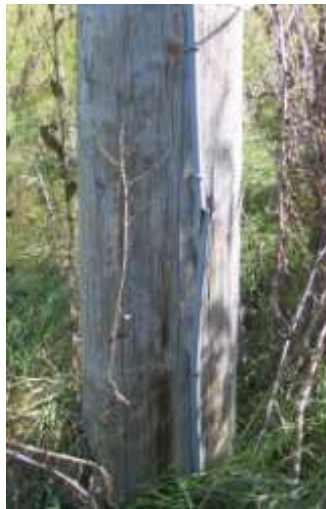
Cut Ground Wire

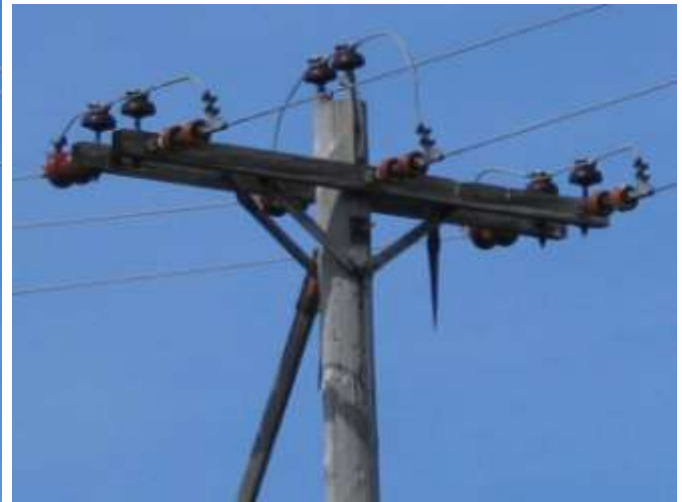
Broken Cross-Arm Brace

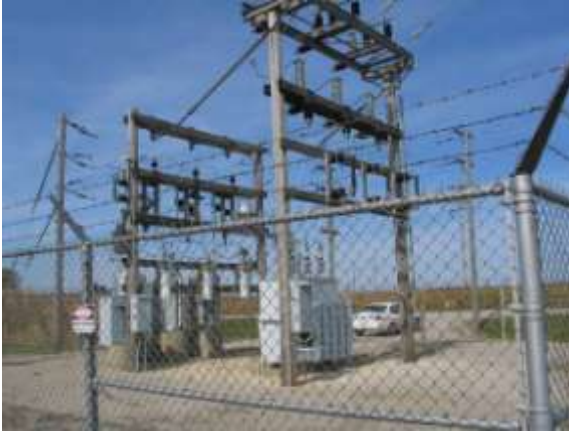
Substation yard was neat & clean

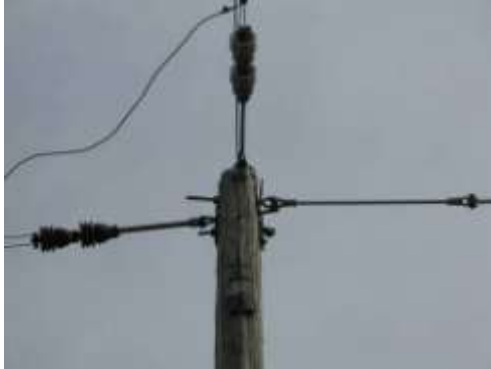
Bad pole top & loose hardware

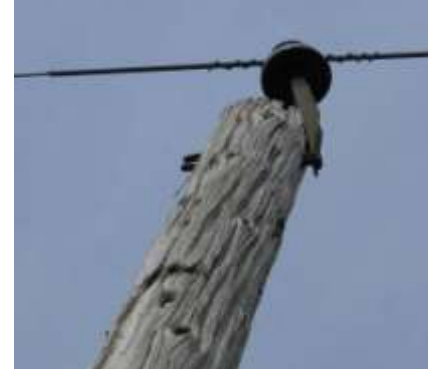
Loose hardware & bad pole top

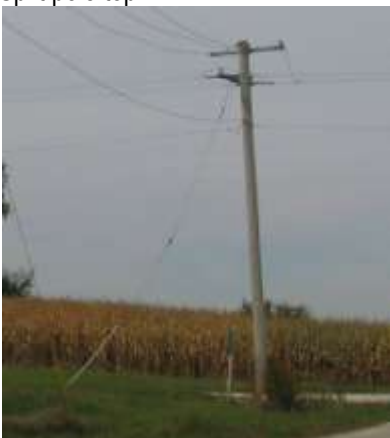
Loose guy wire

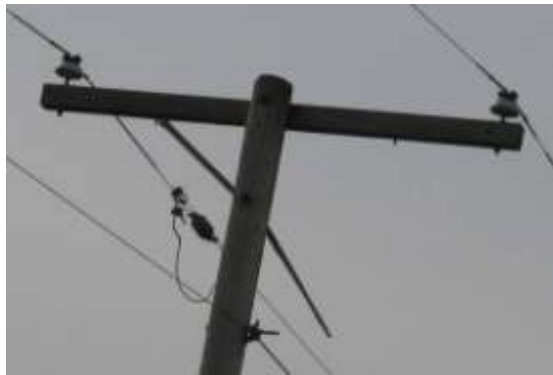
Broken cross-arm brace

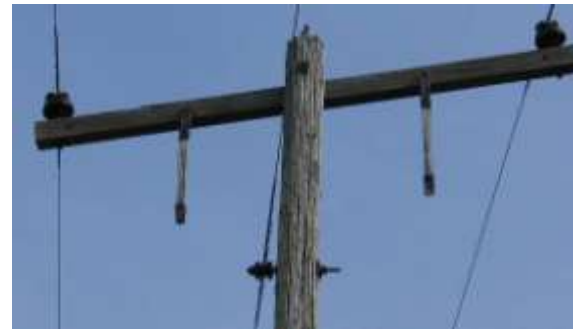
Both cross-arm braces are disconnected (pin connecting them to pole is missing)

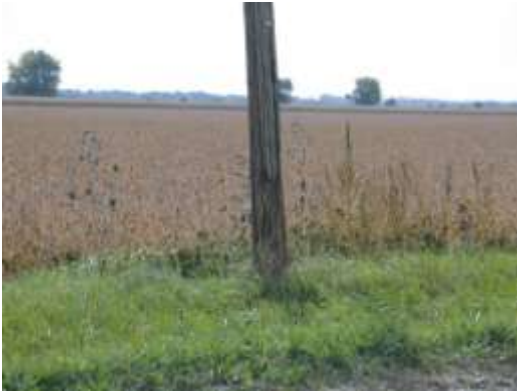
Bad/damaged pole

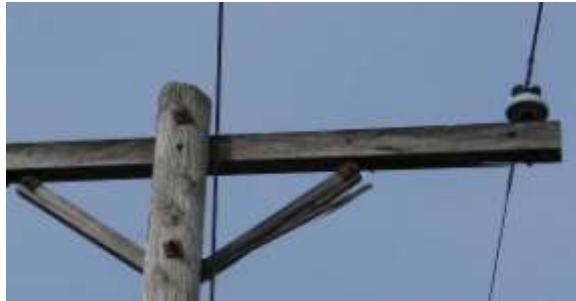
Broken cross-arm brace

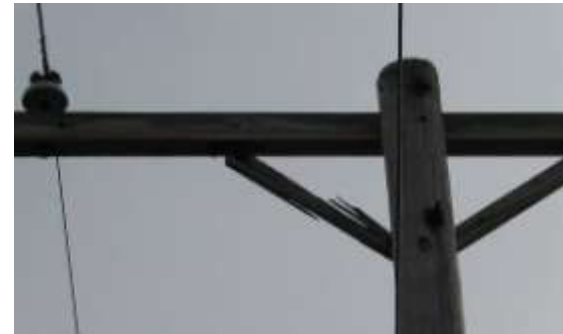
Broken cross-arm brace

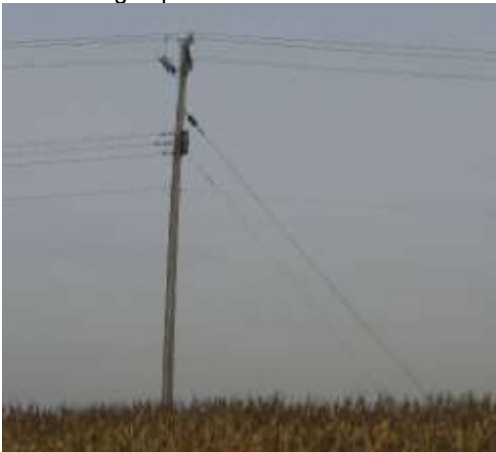
Down guy insulator placement

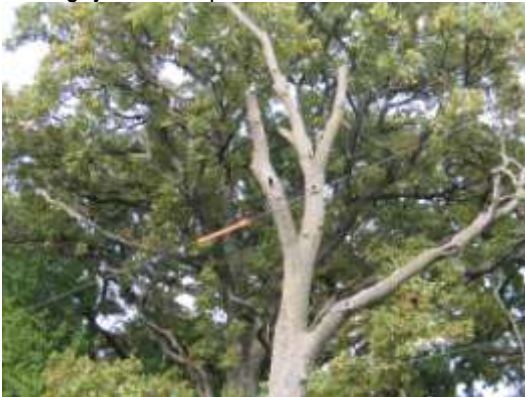
Line hose near dead tree

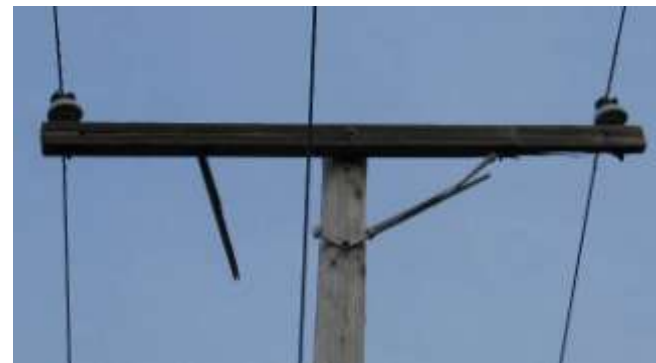
Both cross-arm braces & cross-arm are broken/damaged

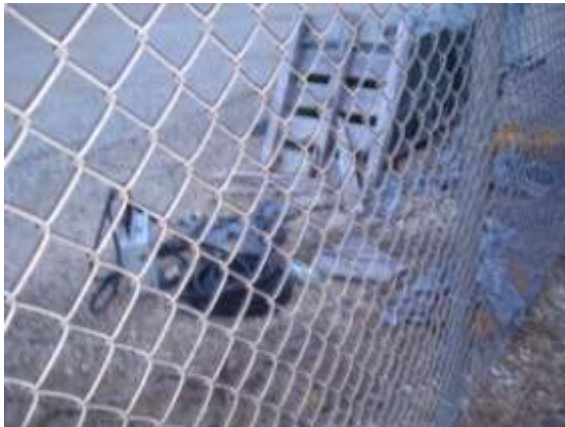
Equipment & trash/clutter in substation yard

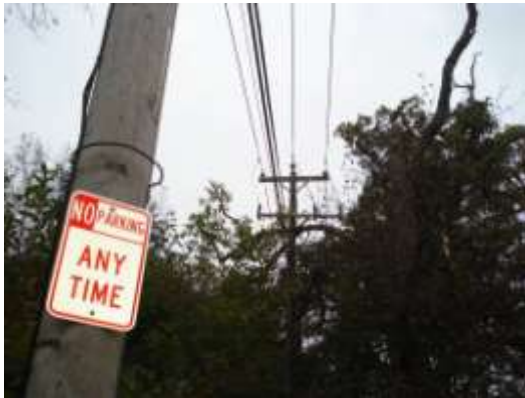
Branches hazard to working on equipment/device

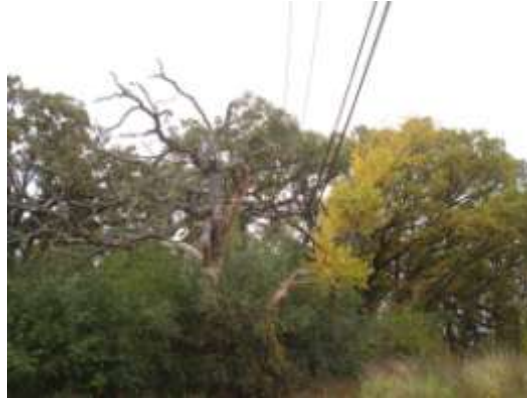
Heavy overhang of trees

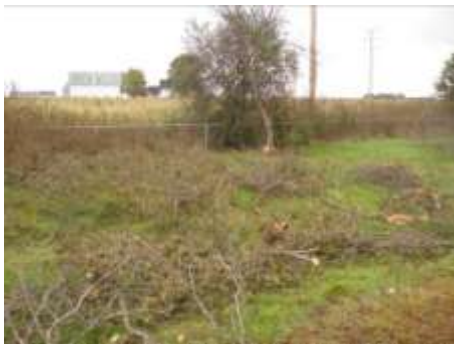
Trees recently cut down in Transmission ROW

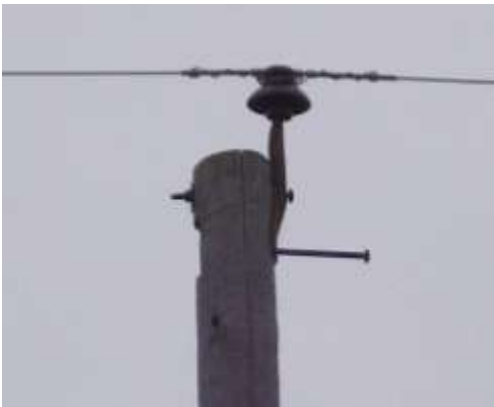
Hardware failure likely under adverse wind or weather conditions

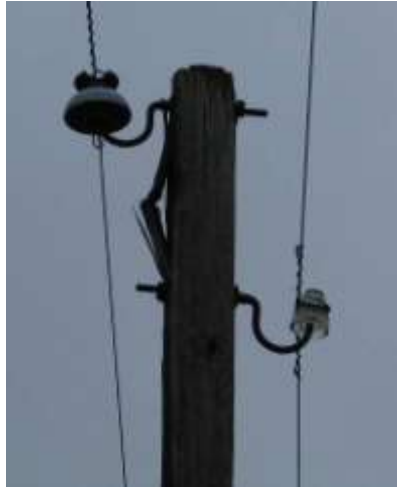
Damaged Pole top

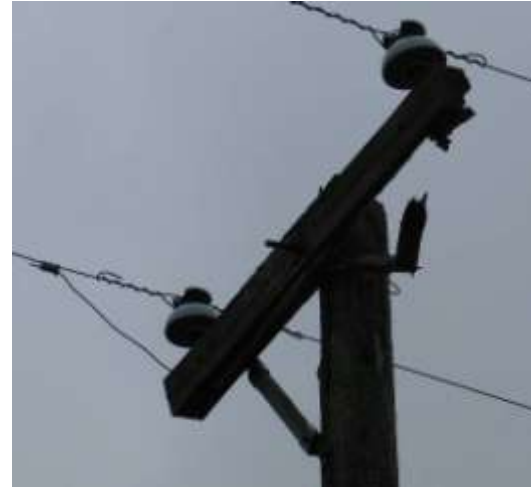
Damaged cross-arm

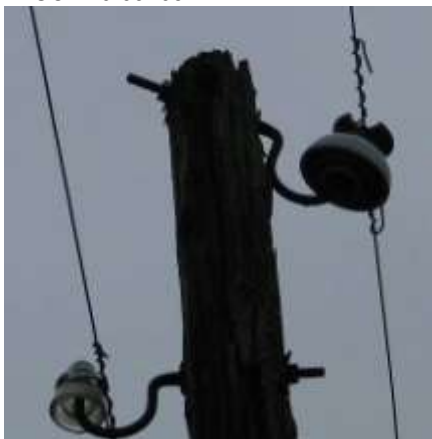
Damaged pole top – hanging hardware – failure eminent

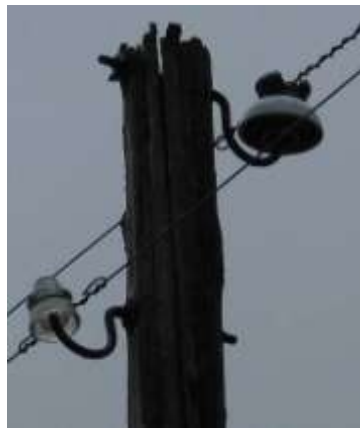
Damaged pole top

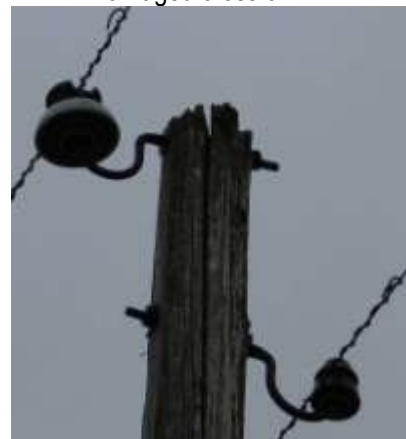
Damaged pole top

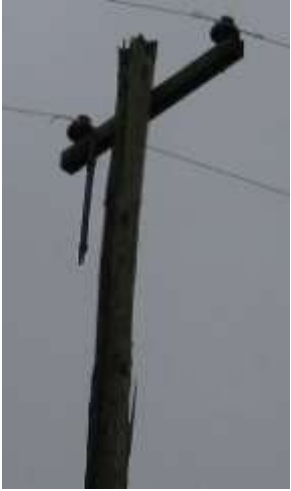
Broken cross-arm brace

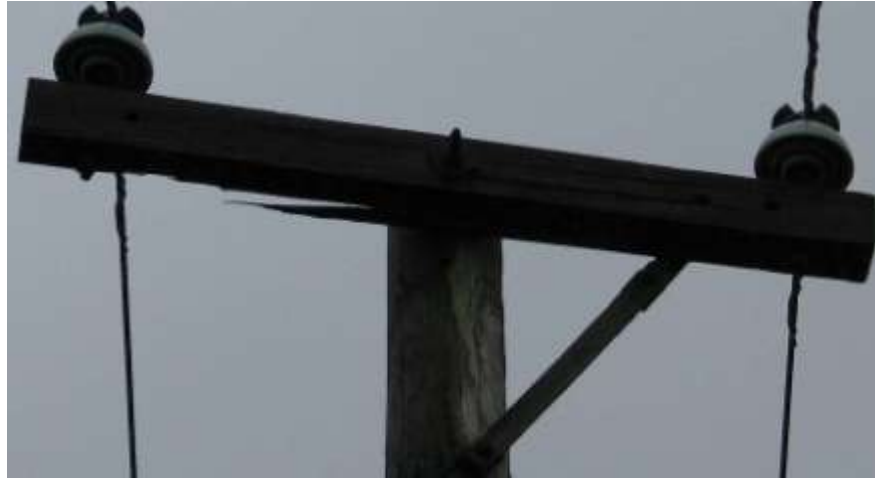
Split cross-arm

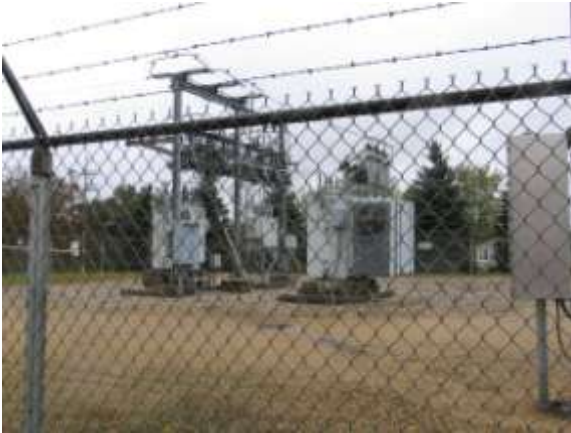
Substation yard clean & in good appearance

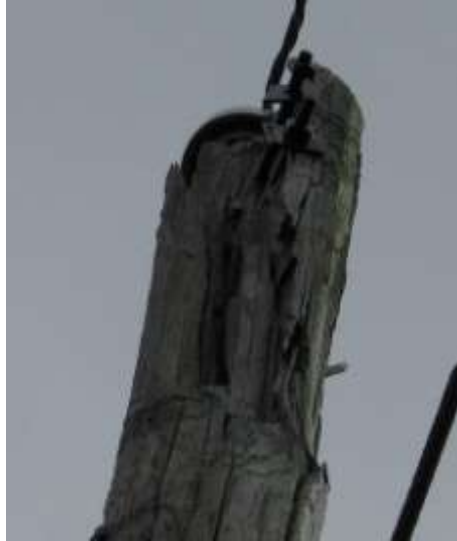
Damaged pole top, HW bolts visible – Failure eminent

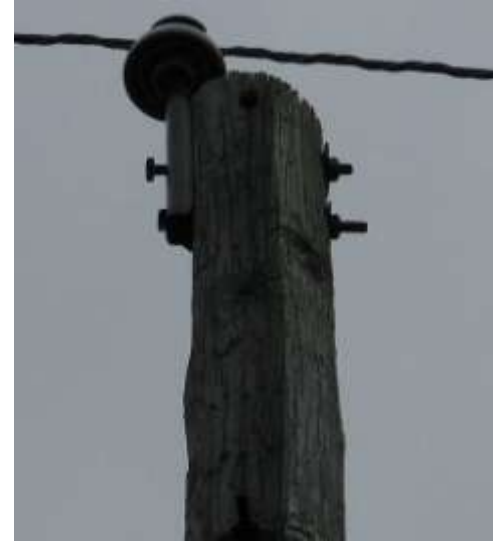
Loose Hardware

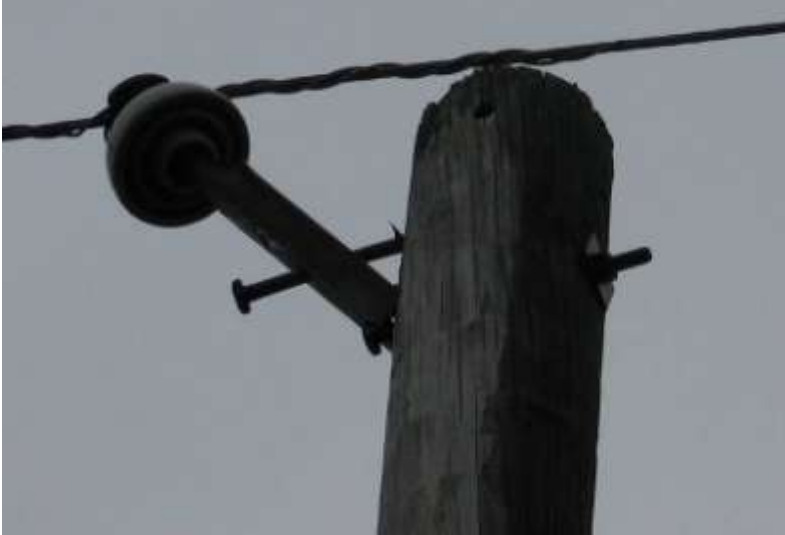
Hardware mount near Failure

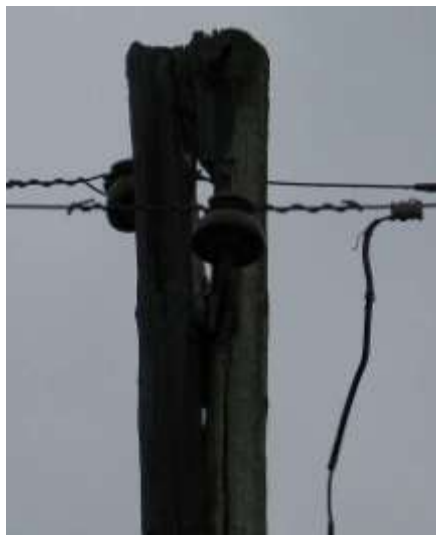
Hardware near Failure

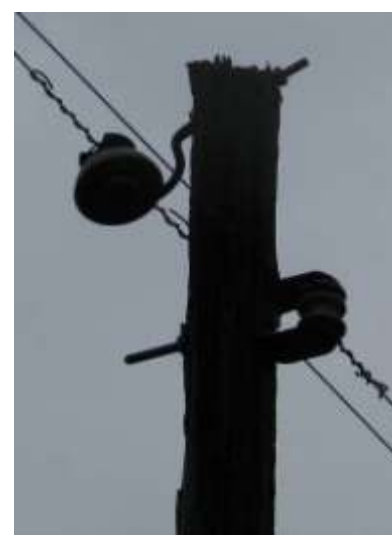
Hardware issue & bad pole top
